Manhole Inspection Summary

Manhole # S39GG_014MH

Location Address: **1218 VALLEY ST**

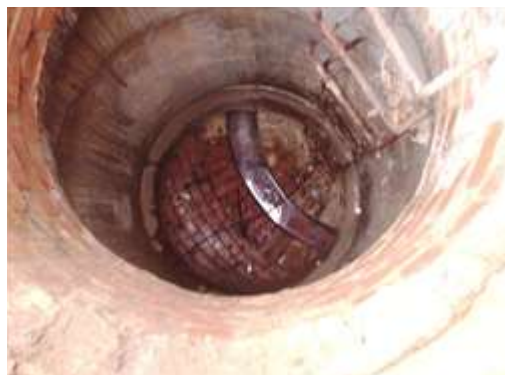
Top View

Adjustment deterioration and infiltration. Corbel and Barrel infiltration. Bench debris.

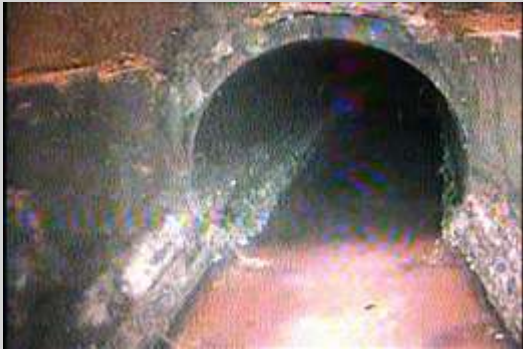
8 in. Circular Gravity Sewer Pipe Out @ 12 O'Clock

Deposits: ☐ None ☐ Mud ☐ Sludge ☐ Debris ☒ **Grease**

Silt Depth: **0** (in.) Deposits Extent: **Light**

Infiltration: **Evidence** Pipe Seal Cond: **Unknown**

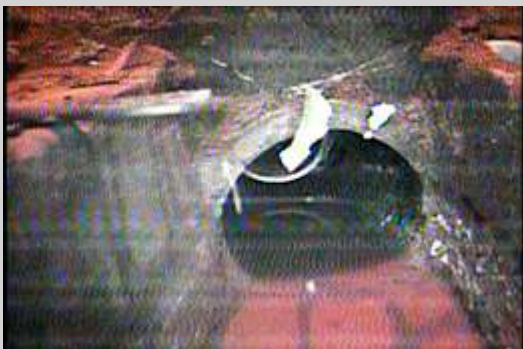
6 in. Circular Gravity Sewer Pipe In @ 4 O'Clock

Deposits: ☐ None ☐ Mud ☐ Sludge ☐ Debris ☒ **Grease**

Silt Depth: **0** (in.) Deposits Extent: **Light**
